**CONCRETE AND ROCK TESTS, REHABILITATION
WORK, MARSEILLES DAM, ILLINOIS WATERWAY
CHICAGO DISTRICT**

Richard L. Stowe

September 1979

Prepared for U. S. Army Engineer District, Chicago
Chicago, Ill. 60604

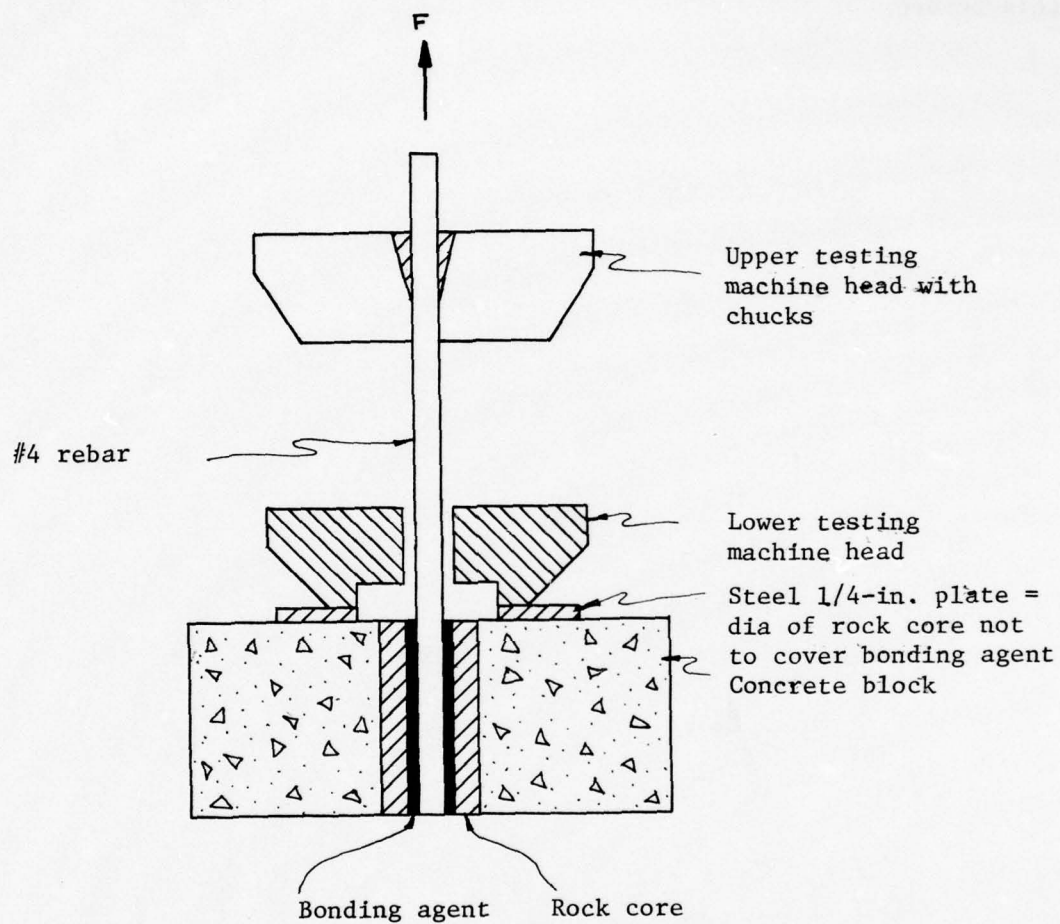
Figure 2 . Section showing test configuration for the reinforcing bar pullout tests.

76. The bond strength calculated from the rebar pullout tests is presented in Table 5. The average bond strength for the Zone 1 and Zone 2 shale were 216 and 31 psi. These strengths represent the bond developed between the cementitious grout used to embed the rebar in the shale and the shale itself. Both values are recommended to be used in the design of any anchorage system at the dam.

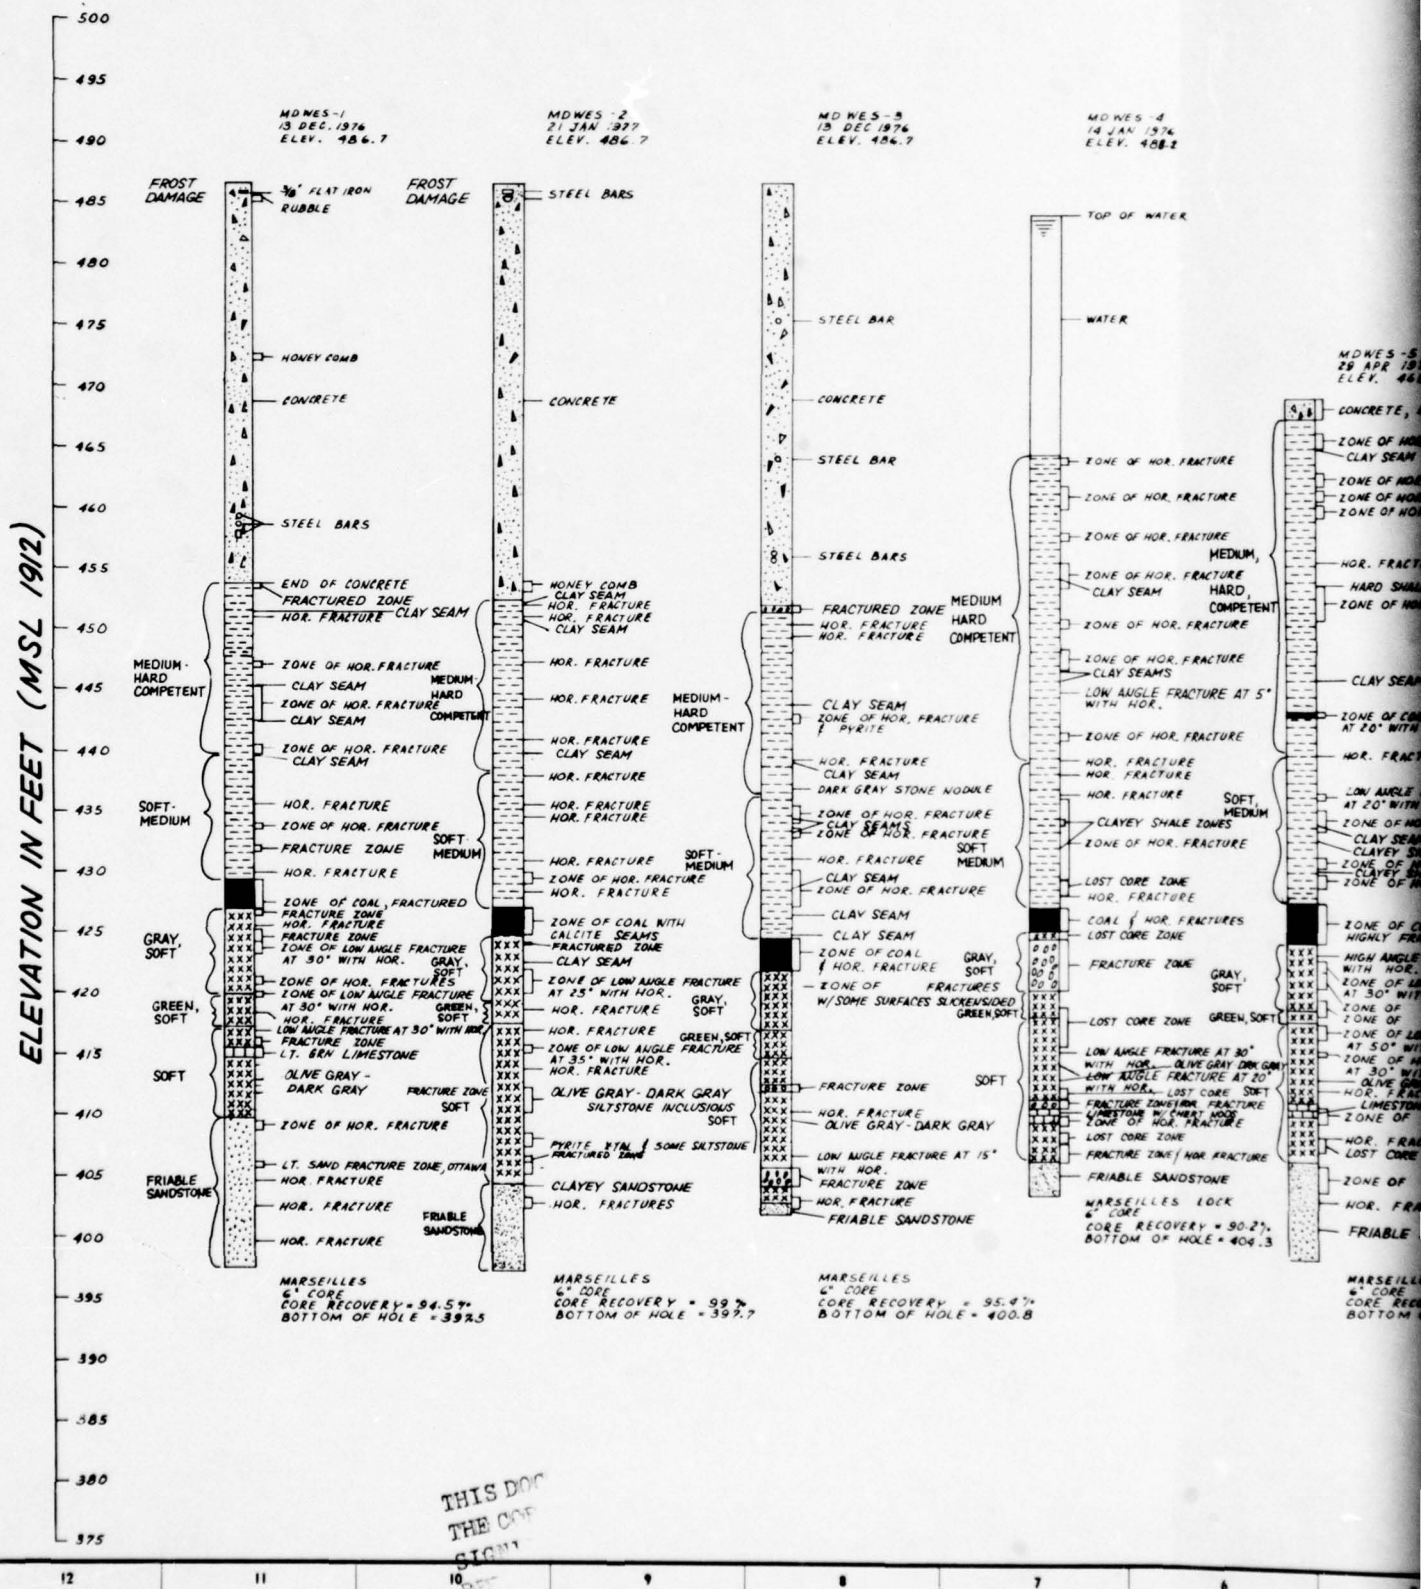
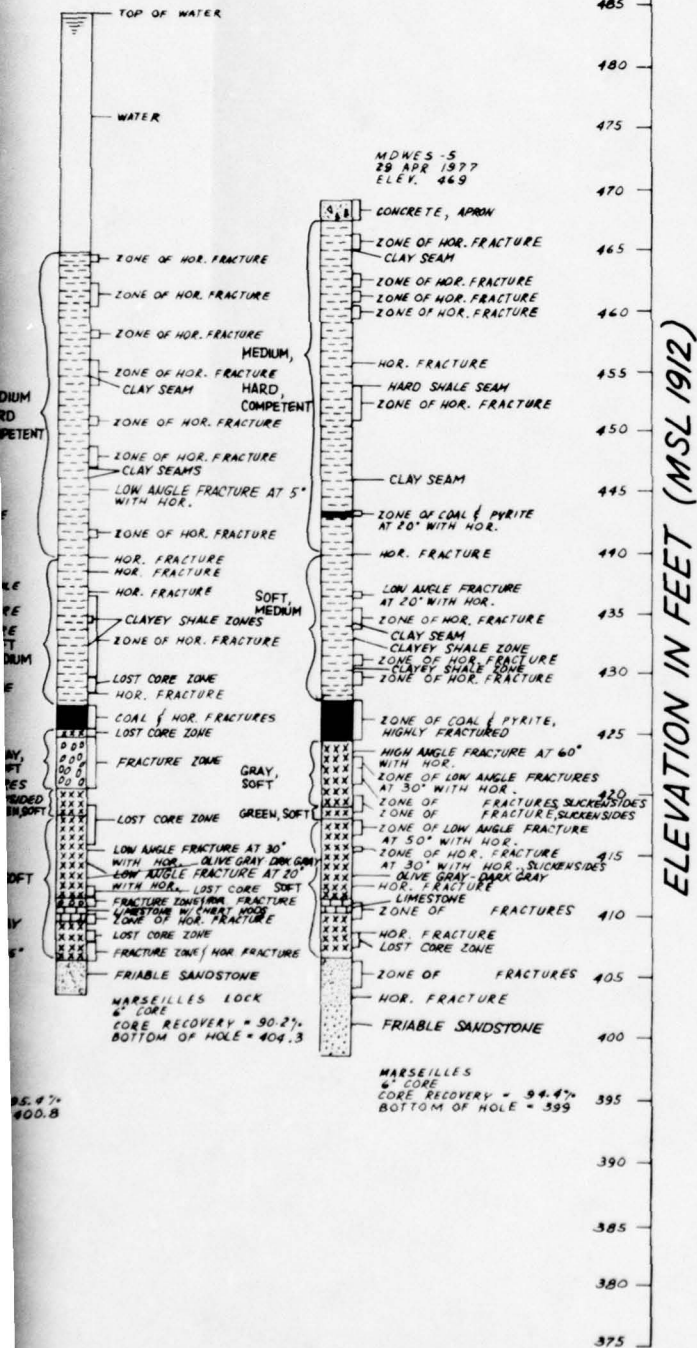
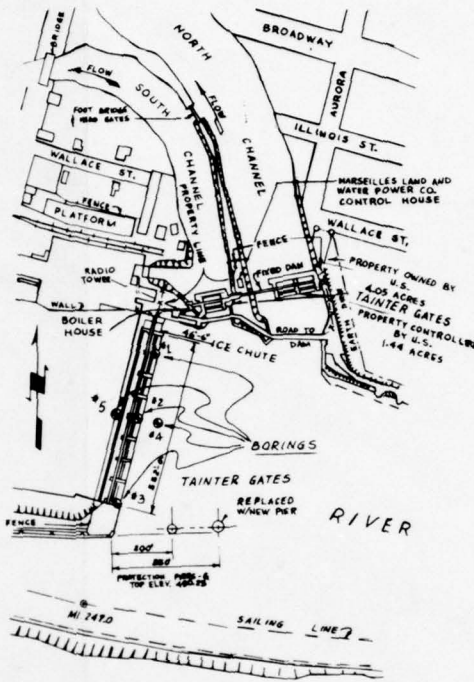
29. The major bedrock structural features relevant to foundations are summarized on the log of borings sheet (see Plate 1); all structural features observed in the core are presented in Appendix A, Plate A1.

33. Possible weak zones in the bedrock under the dam are the fractured shale as found in borings MD WES 2-77 and 3-76 and the thin clay seams (<2 mm thick) and preexisting open bedding planes in the shale strata beneath the dam.

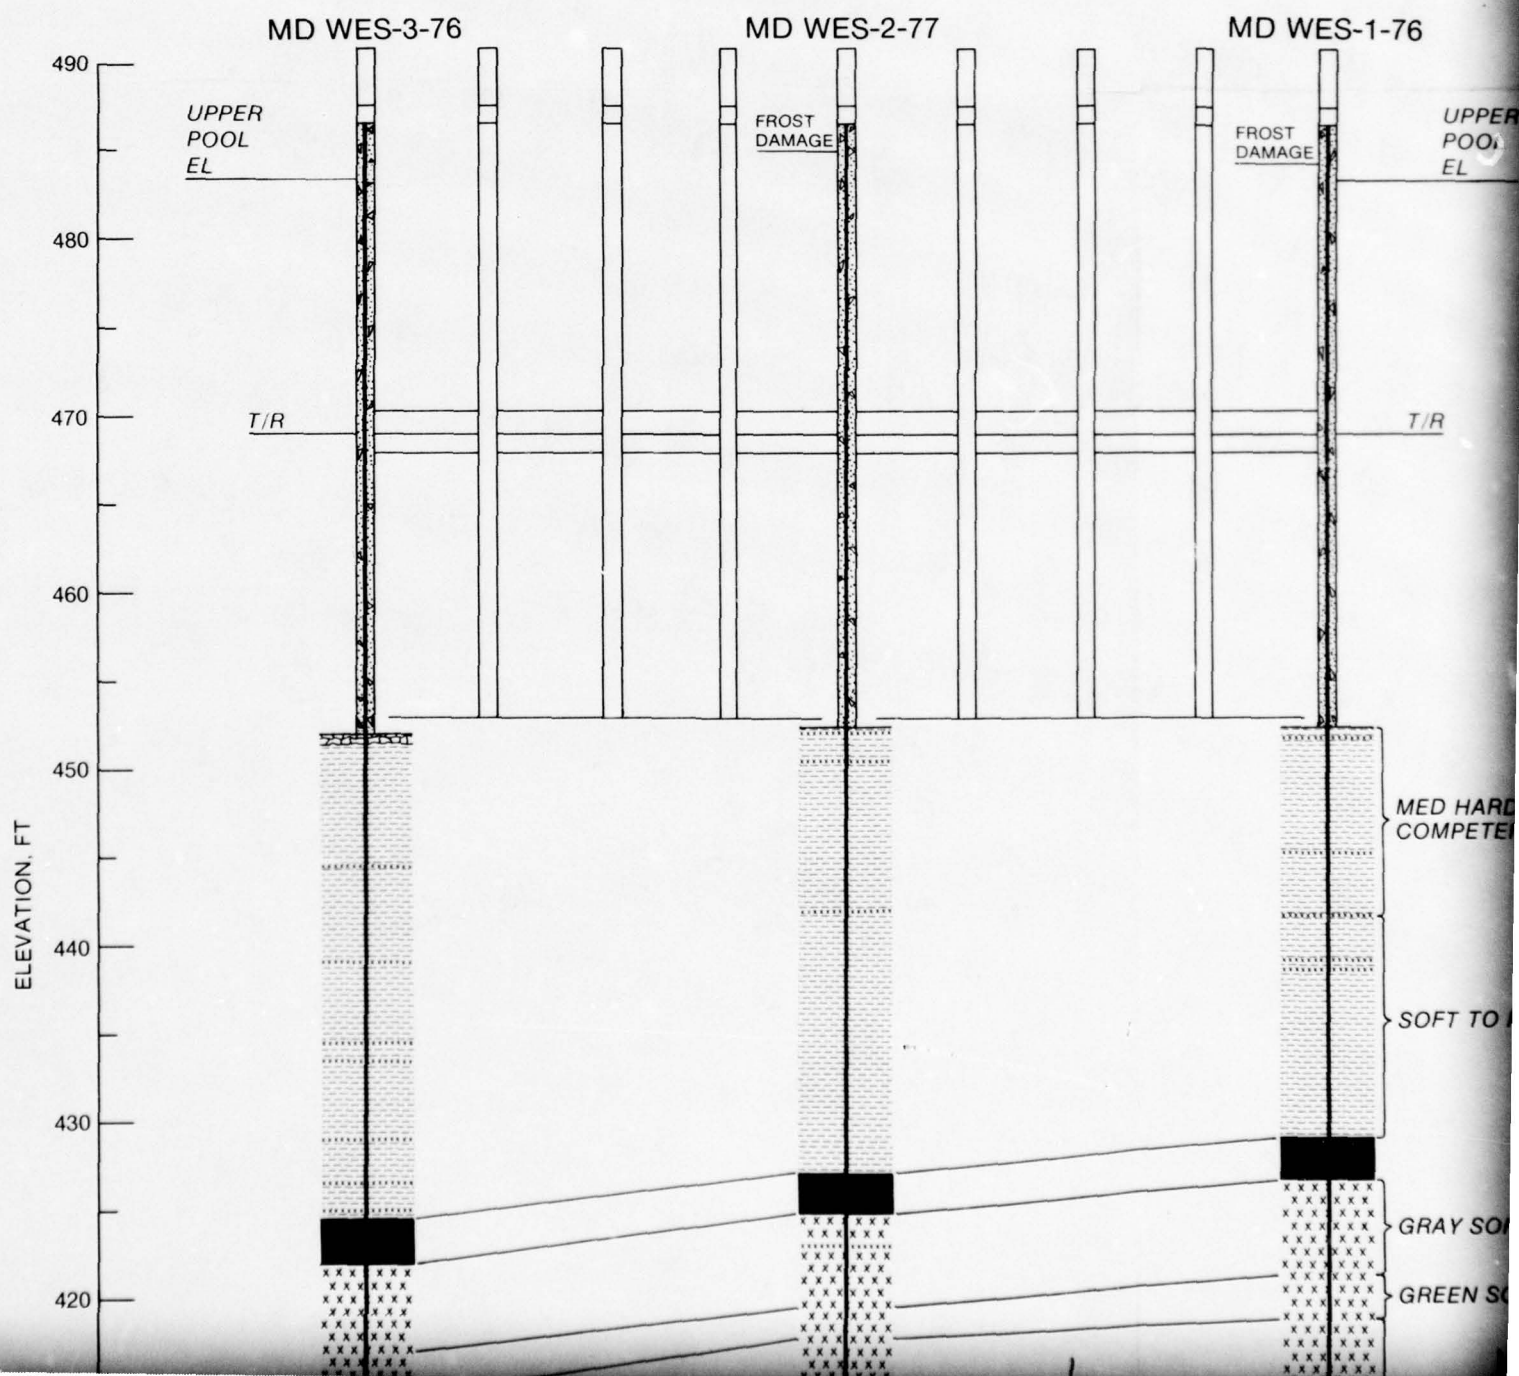
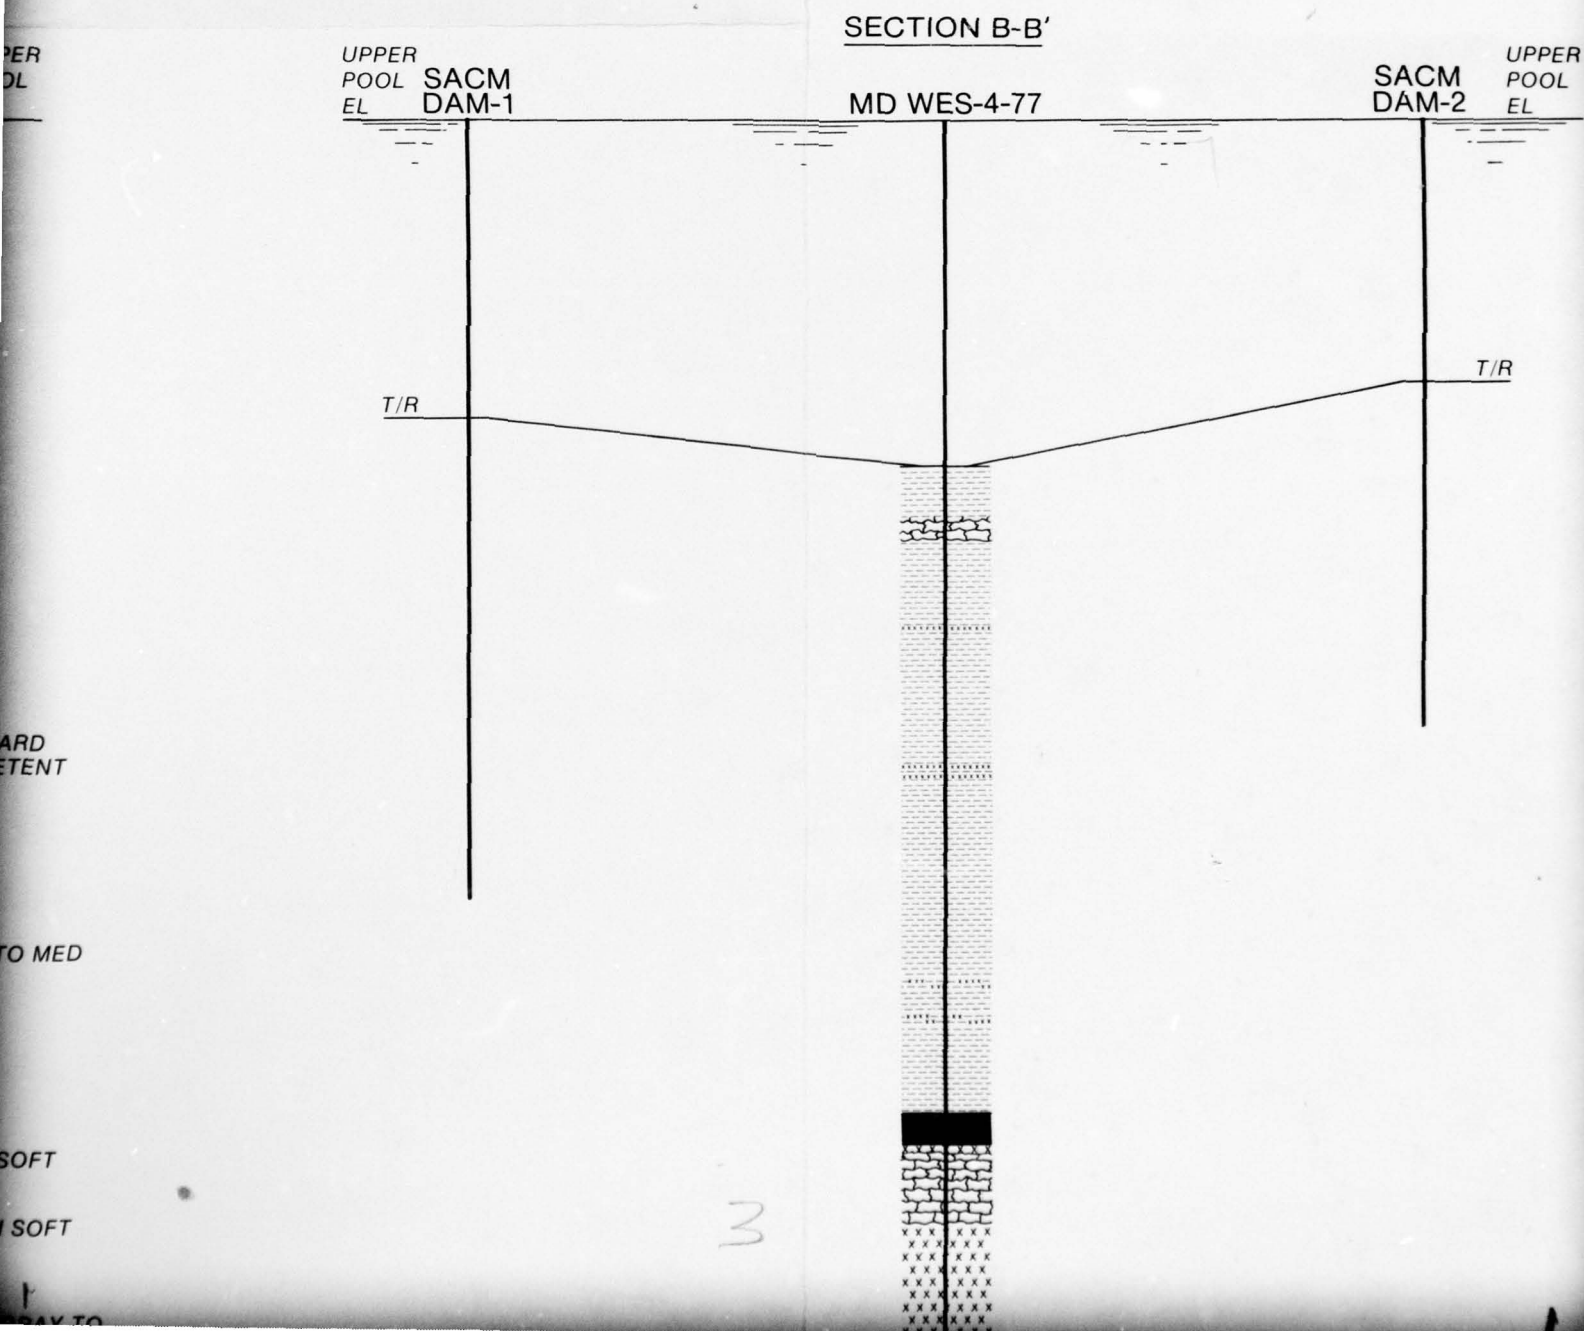
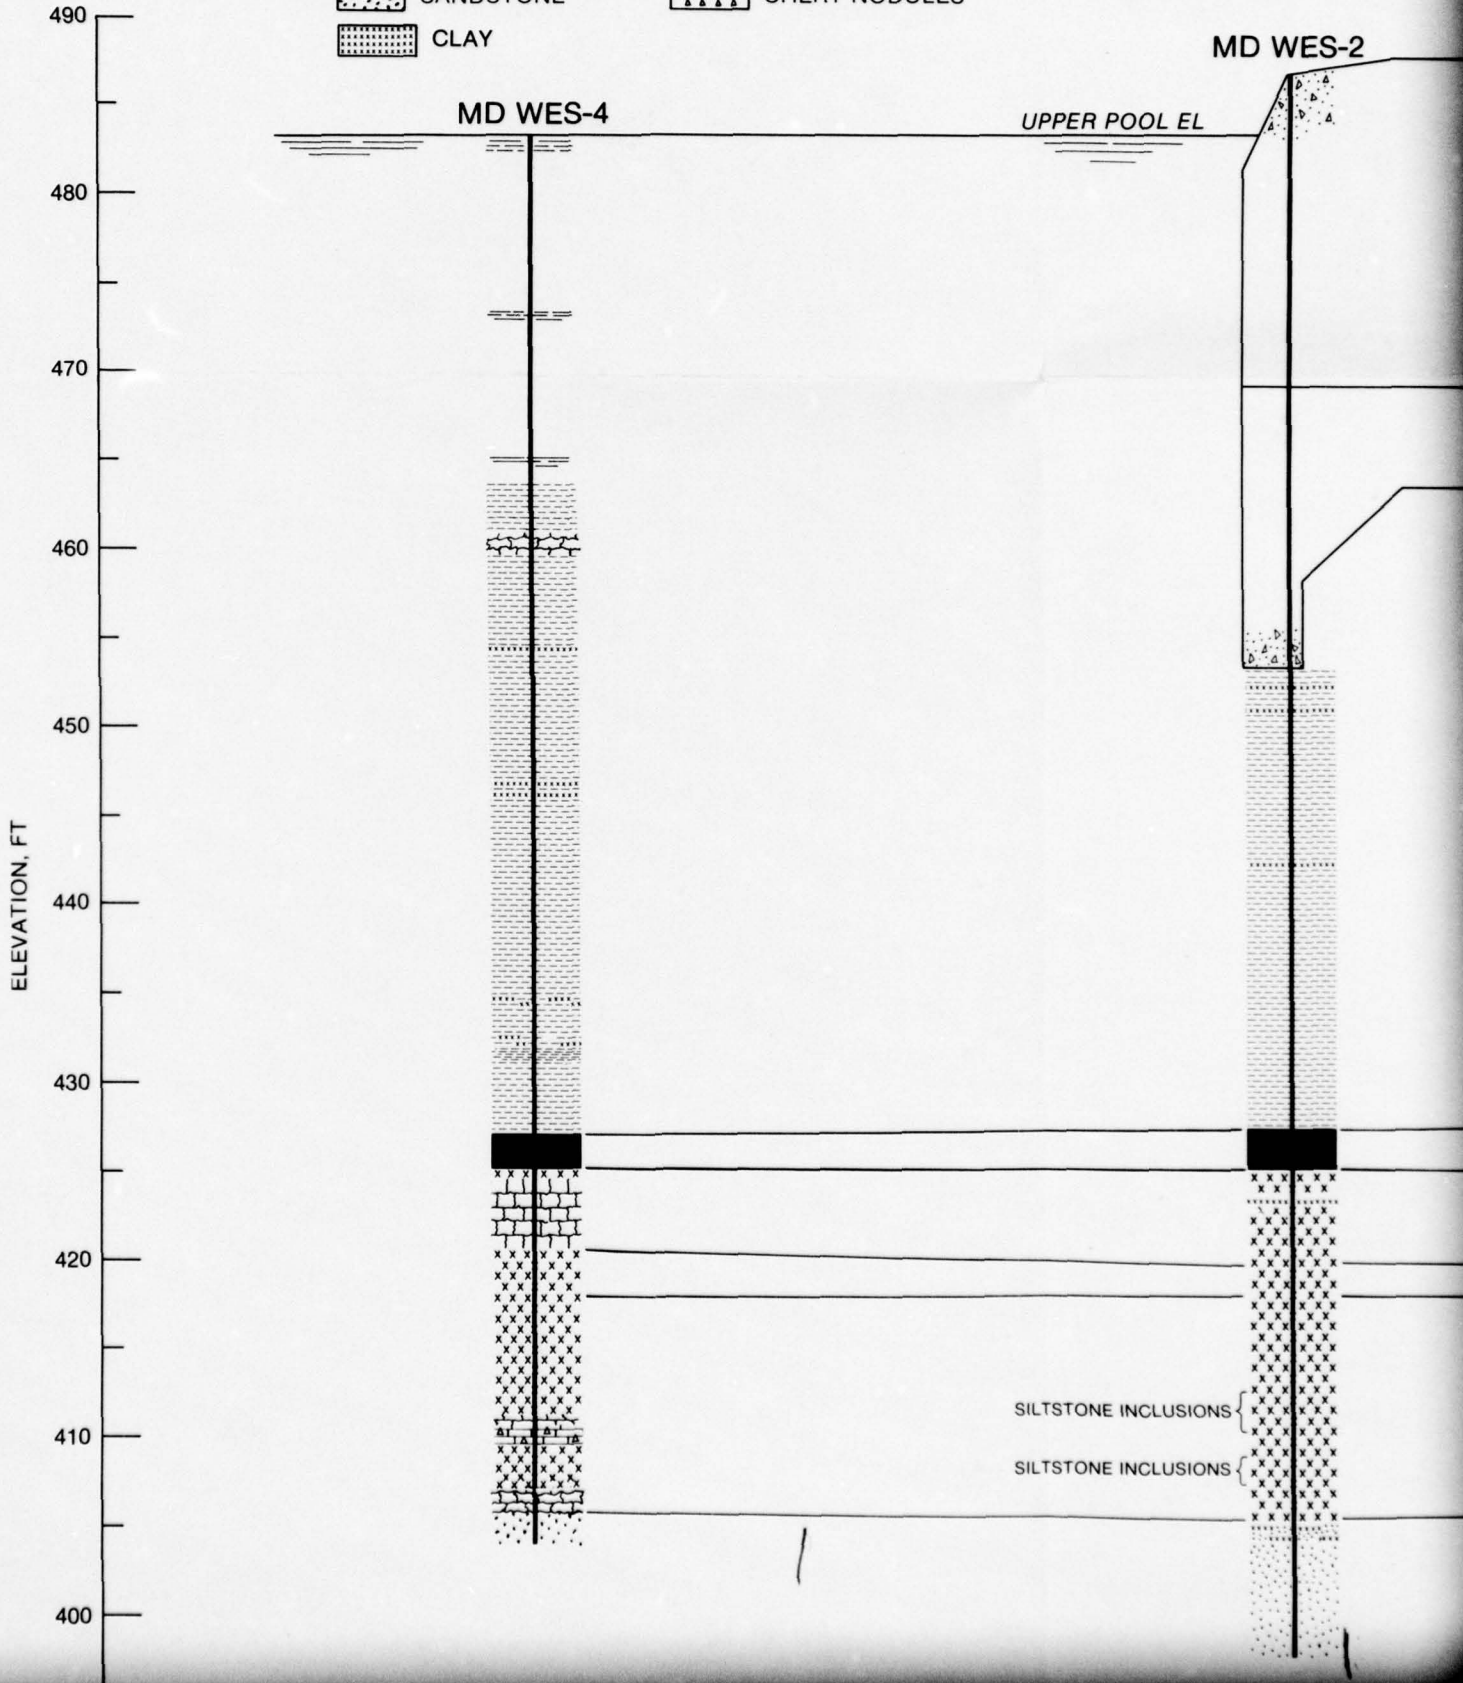
SECTION A-A'

81. The cross sections indicate the extent of deteriorated concrete, the extent of the strata, the continuity of the bedrock beneath and adjacent to the dam, and indicate possible weak zones.

83. The rock between the coal and the sandstone is highly fractured and slickensided; considerable inclined fracturing is present. Because the inclined jointing does not extend into the coal nor the sandstone, this evidence of small scale deformation, jointing, and faulting is considered to be contemporaneous deformation. The water analysis shows that water from the coal seam is not corrosive to steel or concrete.

78. Maximum frost damage reaches to a depth of 1.8 ft in pier 2. The concrete within the first 1.8 ft of the nose sections of the tainter-gate piers, which has deteriorated due to frost action, should be removed before any anchorage system is started. Continual exposure to frost action will cause additional concrete damage at an increasing rate if the concrete remains in place.
